Field Geology Services

Fluvial Geomorphology

May 14, 2013

This letter shall serve as a report on the results of a qualitative geomorphic assessment I conducted for the Taylor Pond Association. The goal of the assessment was to better understand the causes for siltation at the Taylor Pond outlet and to provide management recommendations for controlling flooding and erosion between the outlet and the Hotel Road crossing approximately 950 ft downstream. This reconnaissance level effort consisted of a site visit on April 26, 2013 and a review of: 1) historical aerial photographs available through Google Earth; 2) historical topographic maps accessible online at <http://docs.unh.edu/nhtopos/nhtopos.htm>; and 3) previous letters, reports, and other documents related to the Taylor Pond outlet compiled by the Taylor Pond Association. The findings of the assessment are described below.

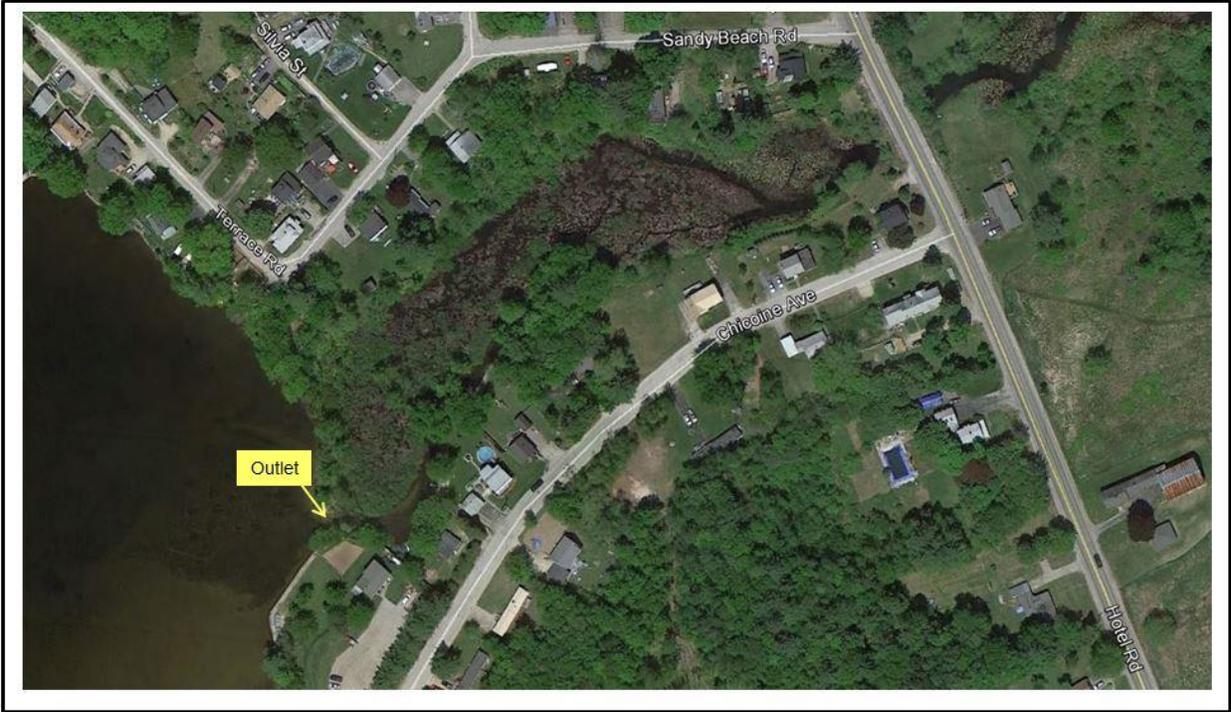
The channel of Taylor Brook at the outlet of Taylor Pond is approximately 10 ft wide and flows along the southern side (or right side of the valley looking downstream) of the 125 ft wide valley (Figure 1). Approximately, 450 ft downstream of the outlet the channel diverges into multiple poorly defined channels that spread across the entire valley. The channels flow through a wetland complex before reconverging just upstream of Hotel Road into a well defined single 25 ft wide channel. An historical topographic map from 1908 shows a single channel extending from the outlet to the Hotel Road crossing and beyond (Figure 2), but smaller channels that existed at the time may not have been shown. Historical aerial photographs extending back to 1997 on Google Earth demonstrate multiple channel threads have been present for at least the past 15 years between the outlet and the Hotel Road crossing.

Figure 1. Aerial photograph from Google Earth of the Taylor Pond outlet area.

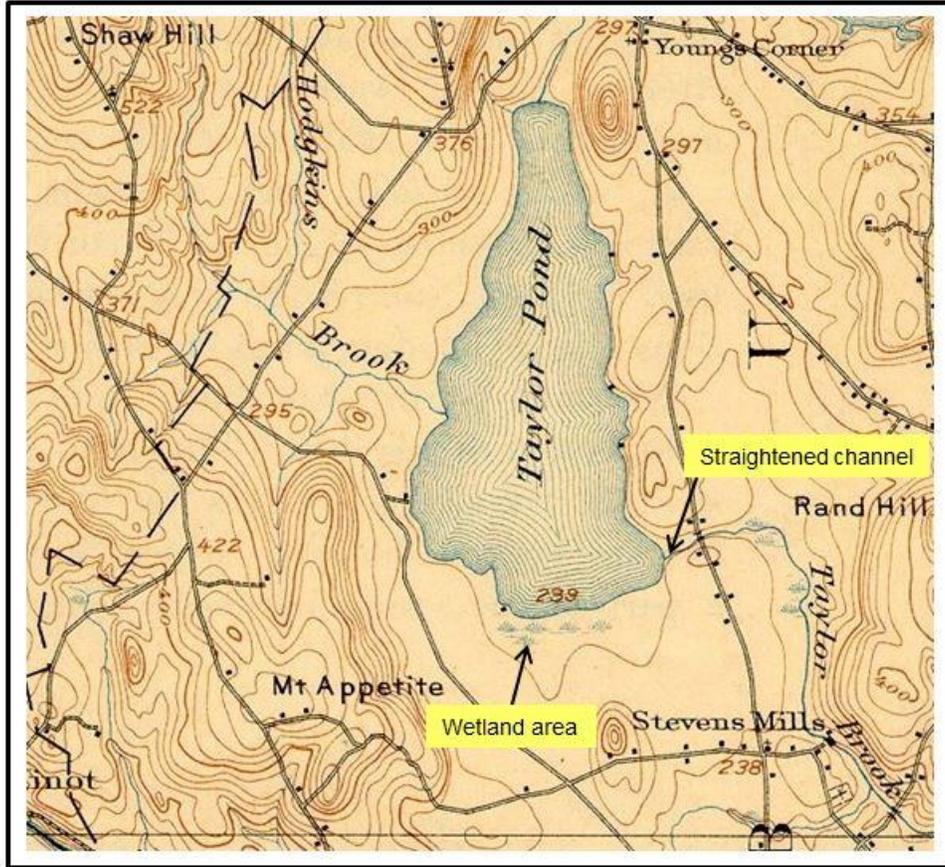
Efforts to manage siltation at the Taylor Pond outlet have likely been ongoing since the early 20th century. The 1908 historical topographic map shows the Taylor Brook channel between the outlet and Hotel Road in a nearly straight alignment flowing along the southern edge of the valley. Although other side channels may have been present at this time, as described above, the straight alignment along the valley margins are indicative of an artificially straightened channel. The straightening was likely undertaken to increase flow velocity and thereby reduce flooding and siltation of the channel. However, by containing flow in a single channel, the erosive force of the stream would be increased and may be contributing to present-day erosion problems being managed at the outlet (Figure 3).

Figure 2. Topographic map of Taylor Pond from 1908 showing wetland at southern margin of pond and straightened channel at outlet.

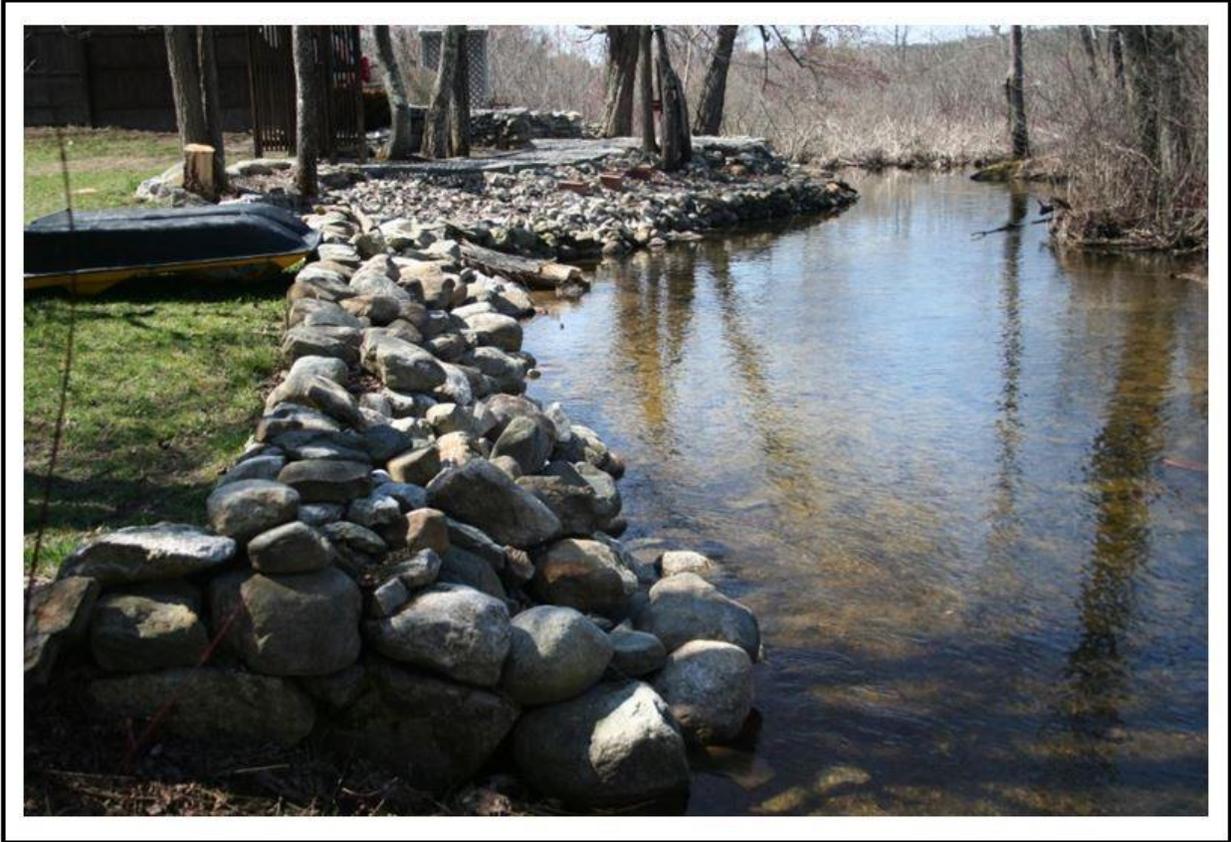
Local residents have expressed concern about flooding and erosion in the outlet area. Previous letters and other documents regarding the outlet area demonstrate that these concerns have been expressed at various times over the past 30 years and likely longer. A riprap revetment was constructed along the southern edge of the valley just downstream of the outlet to address bank erosion (Figure 3). Other landowners have expressed concern regarding flooding and erosion along the northern edge of the floodplain downstream of where the brook diverges into multiple channels. While bare sloughing banks, typical of severe erosion, are not evident at

this location, recent sand deposition along the edge of the floodplain indicates at least minor flooding of neighboring lawns is possible.

Figure 3. Riprap revetment constructed to manage bank erosion just downstream of the Taylor Pond outlet.

Future management of Taylor Brook in the outlet area must be conducted with this understanding of a natural tendency towards siltation. Great expense could be incurred removing the Stevens Mill Dam and enlargening the Hotel Road crossing with little increase in flow velocity or reduction in siltation. If the channel is to be dredged, straightened, and confined to a single channel, such efforts must be undertaken with the realization that such management efforts will need to be periodically repeated as the channel once again fills with silt and multiple channel threads develop. Since the erosion resulting from siltation in the channel is unlikely to severely impact homes and other infrastructure immediately adjacent to the floodplain margins, vegetative solutions are the most sustainable management approach for the erosion problems. Plantings along the banks of those channels that flow along the margins of the floodplain will serve to absorb the channel's erosive energy without unduly transferring erosive forces downstream as can occur when using rock riprap.

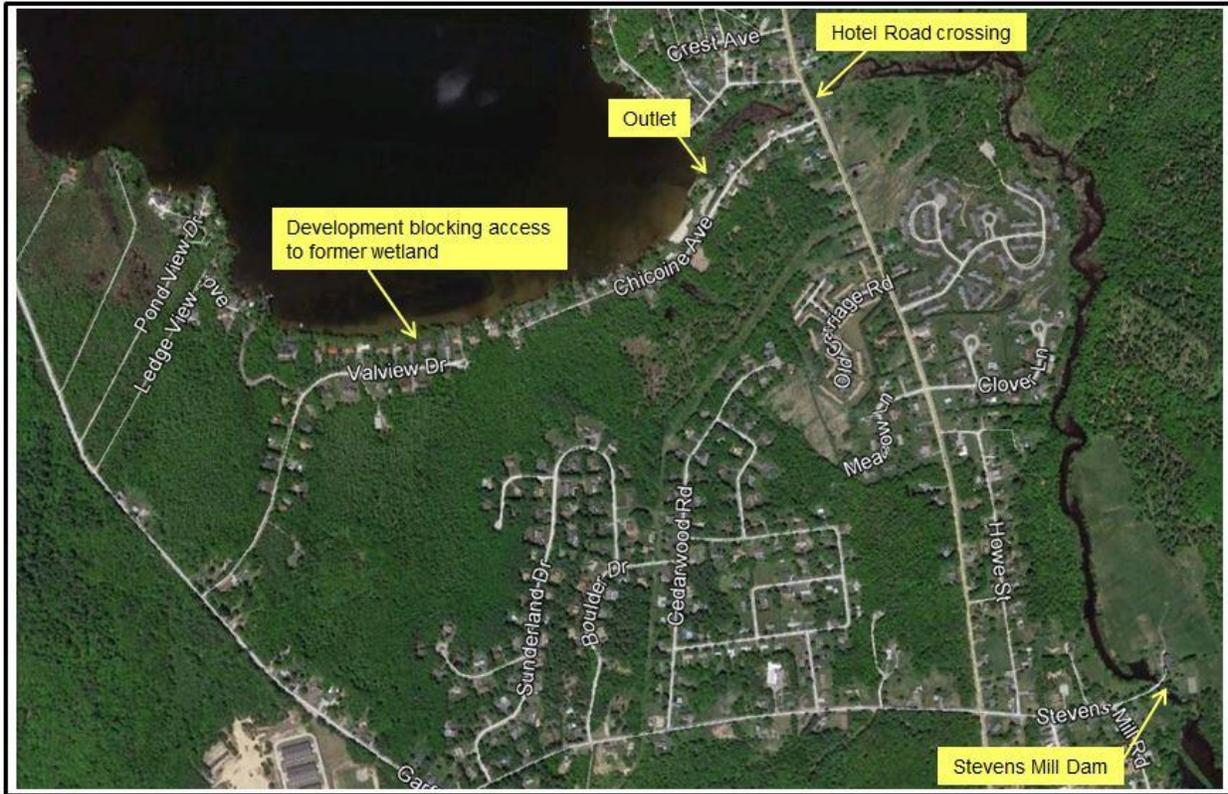
Human alterations along Taylor Pond and Taylor Brook have also potentially increased flooding in the outlet area. A comparison of the 2012 aerial photograph (Figure 4) and 1908 topographic map (Figure 2) illustrates how the construction of homes and associated berms in the 1970's has blocked off a former wetland along the southern margins of the pond. Previously, the wetland area would have provided flood storage during periods of high flow, but now that flow more quickly reaches the outlet. Other development throughout the watershed has also been discussed in previous documents as a potential cause for increased flooding since previously forested areas have been converted into homes, roads, and other impervious surfaces that lead to greater runoff. The presence of the Stevens Mill Dam and the Hotel Road culvert may lead to flow impoundment and higher flood stages in the outlet area. Hydrologic and hydraulic modeling would be needed to determine how significantly these various factors alter flood stage for various rainfall events and discharges, but the impact of increased runoff due to development in the watershed is likely minimal given the still small percentage of development in the 14.9 mi² watershed.

Figure 4. Aerial photograph from 2012 showing development blocking former wetland area.
