Taylor Pond

Watershed Survey Report

**Androscoggin Valley Soil and Water Conservation District
Taylor Pond Association
Maine Department of Environmental Protection**

June 2006

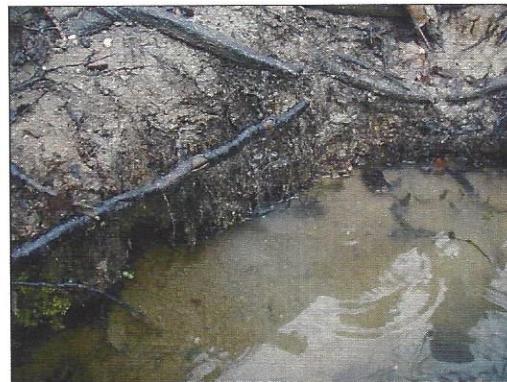
When combined with many other similar sites throughout a watershed, even erosion from small sources such as this can have a significant impact on lake water quality.

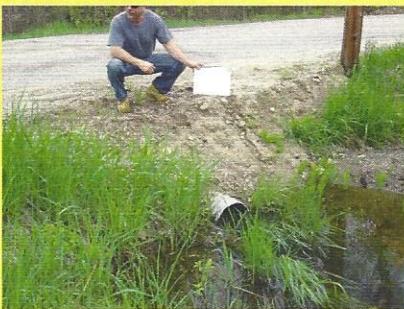
Problem— Unstable road shoulder and culvert erode sediment into stream
Solution— Armor with stone riprap

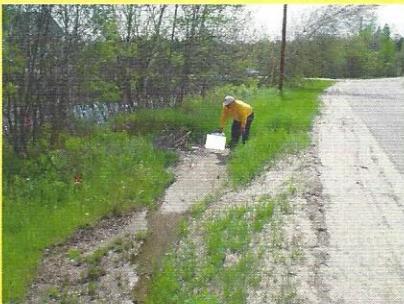
Problem— Shoulder erosion and inadequate ditching delivers sediment directly into stream
Solution— Reshape and vegetate ditch; Install check dams to trap sediment

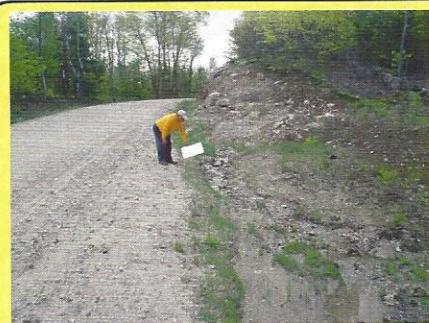
Problem— Inadequate ditching with erosion and sediment accumulation
Solution— Reshape ditch, clean out sediment, vegetate, and install check dams

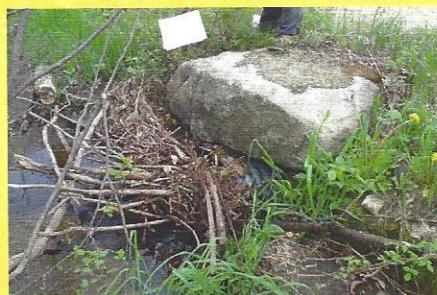
Problem— Culvert clogged with debris
Solution— Remove debris and regularly inspect culverts to ensure proper functioning
