Taylor Pond Watershed Survey Report

June 2023

Prepared for:
Taylor Pond Association
585 Garfield Rd
Auburn, ME 04210
www.taylorpond.org

Prepared By:
Androscoggin Valley Soil & Water Conservation District
254 Goddard Road,
Lewiston, ME 04240
www.androscogginswcd.org

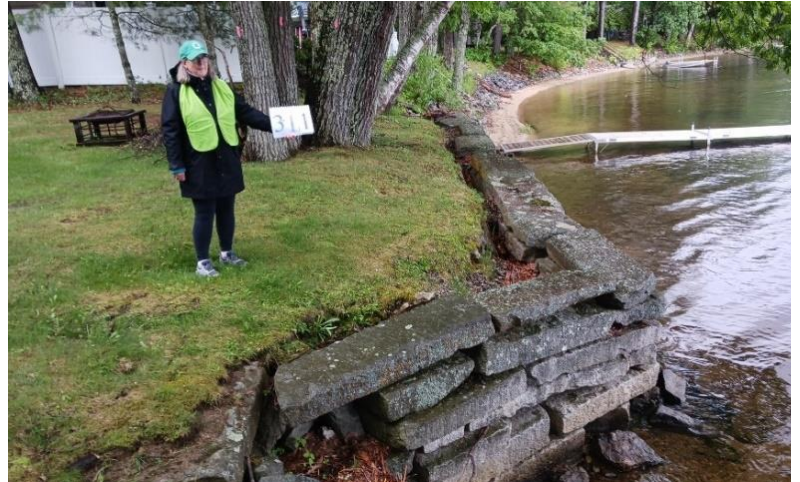
Figure 9: More dramatic erosion identified on a residential site.

Runoff is eroding the shoreline behind retaining wall is eroding, causing other problems.

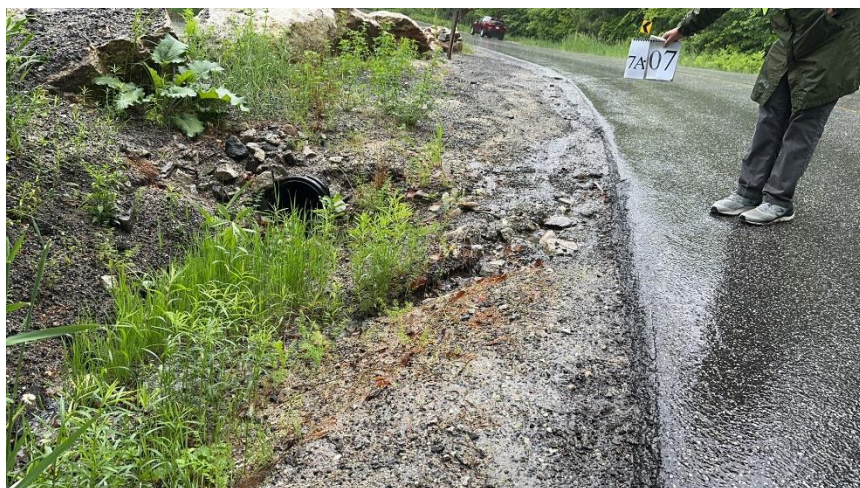
Figure 11: A high-impact town road

Gully forming and eroding road shoulder on Harris Road. Culvert is perched and too small. Survey team recommends replacing and enlarging the culvert, installing check dams in the ditch, vegetate shoulder, and armor culvert with stone.

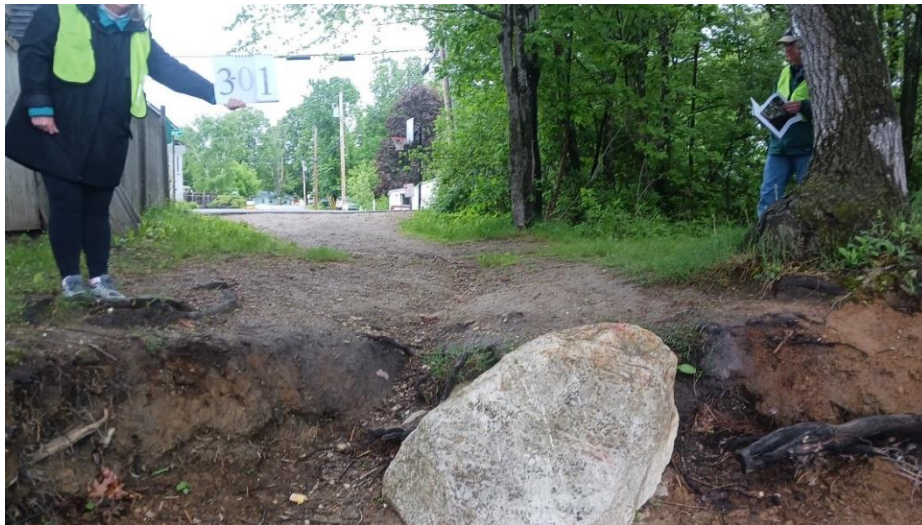
Figure 12: High-Impact Beach Access site

Road shoulder uphill from beach access is eroding and bringing runoff directly to pond. Survey team recommends installing runoff diverters, defining foot path, improve buffer and address ditching issue on uphill roadway.

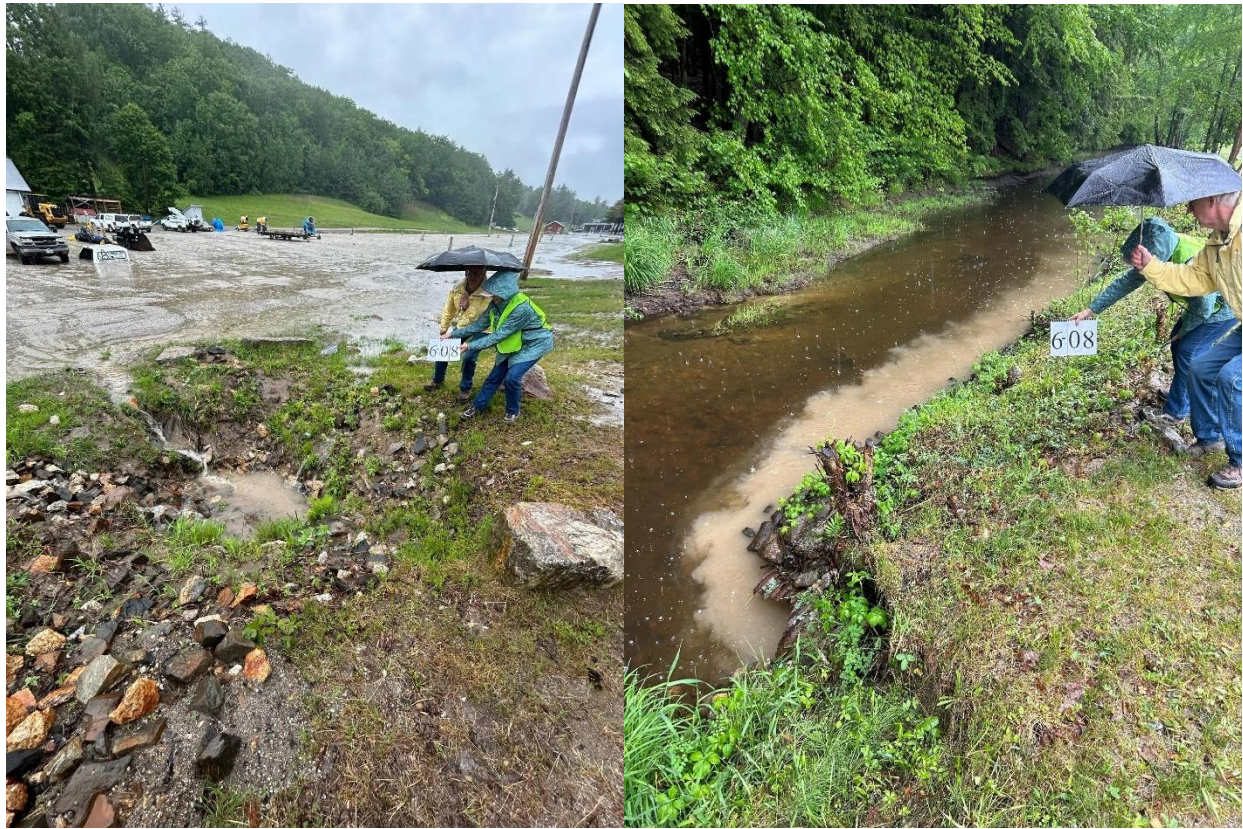
Figure 14 + 15: High Impact Commercial Site

Severe runoff from parking lot is depositing sediment directly into the stream. The problem is very visible during high flow events.

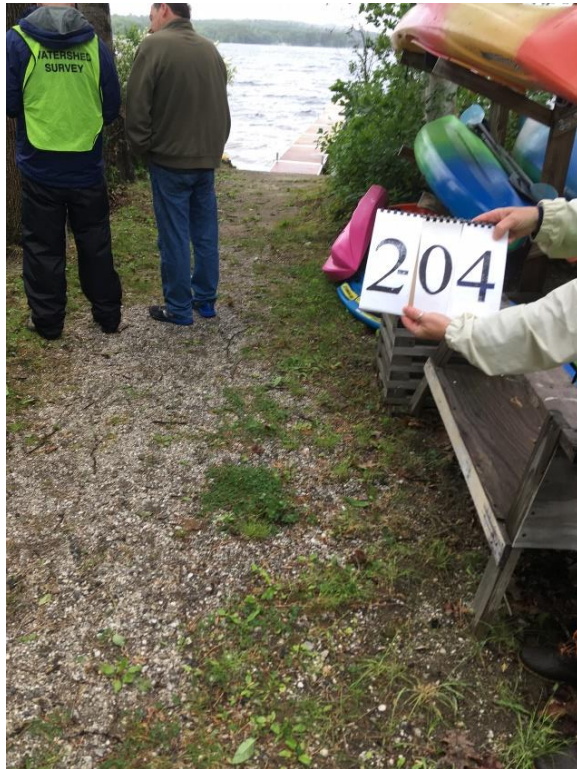
Figure 16: Low Impact Trail/Foot Paths Site

Surface erosion found leading directly to lake.
Recommendation to cover with erosion control mulch, install runoff diverter and stabilize foot path.

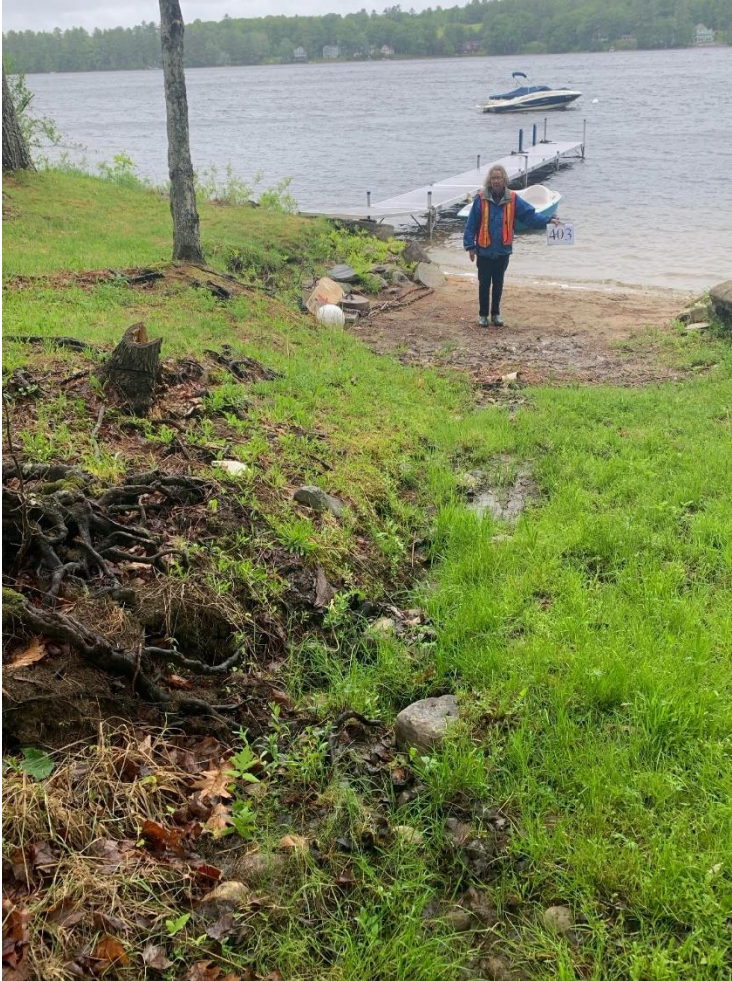
Figure 21: High Impact Private Road Site

Rill/Gully Erosion leading directly to lake.

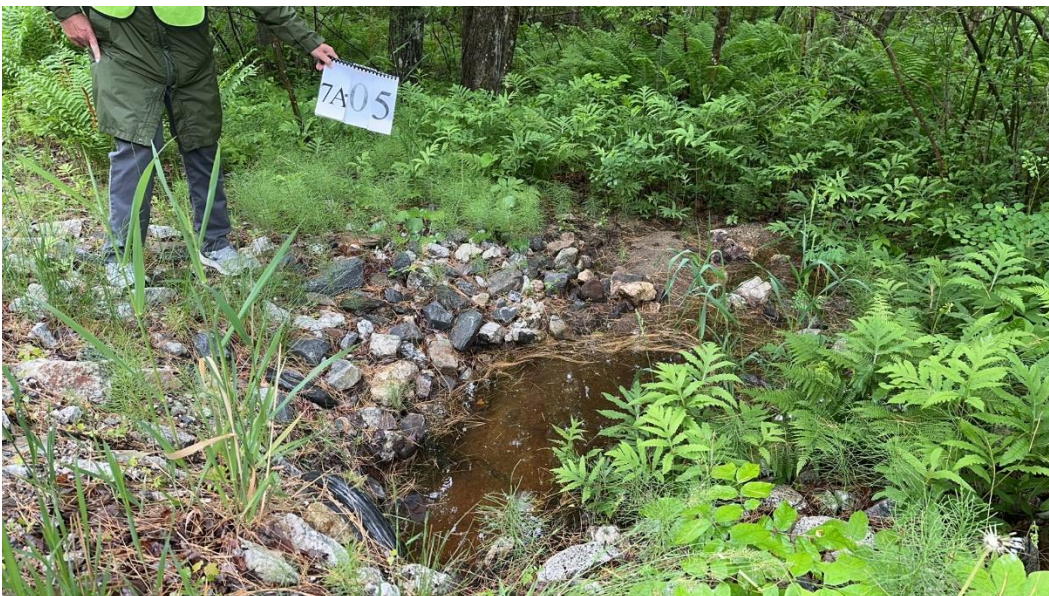
Figure 22: High Impact Town Road

Road shoulder erosion and sediment deposition directly into stream
