Taylor Pond Watershed Survey Report

June 2023

Prepared for:
Taylor Pond Association
585 Garfield Rd
Auburn, ME 04210
www.taylorpond.org

Prepared By:
Androscoggin Valley Soil & Water Conservation District
254 Goddard Road,
Lewiston, ME 04240
www.androscogginswcd.org

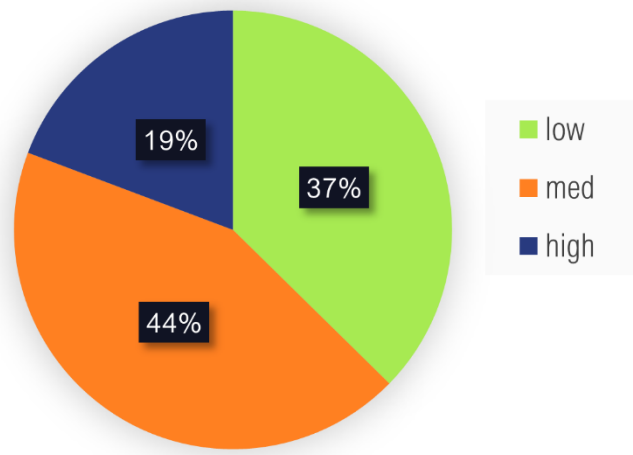
Figure 4: Percentage of Sites by Impact Score

Each site identified during the survey was rated for its potential impact on the lake (Figure 4). Impact is based on the size of the site, its slope, amount of soil eroded, and proximity to water. Of the 83 sites identified during the survey **31 were marked as low impact**—meaning sites with limited soil transport off-site. **36 sites were identified as medium impact**—meaning sites where sediment is transported off-site, but not at a high magnitude. Only **16 sites were identified as high impact**—large sites with significant erosion that flows directly into a stream or the pond. High impact sites are contributing the most to the pollution of the pond and decline of water quality. High impact sites should be addressed first, but low impact sites may be easily fixed by landowners.

Impact to the pond was assigned by considering the size of disturbed area, slope, soil type, amount of soil eroding, proximity to water, and size of buffer.

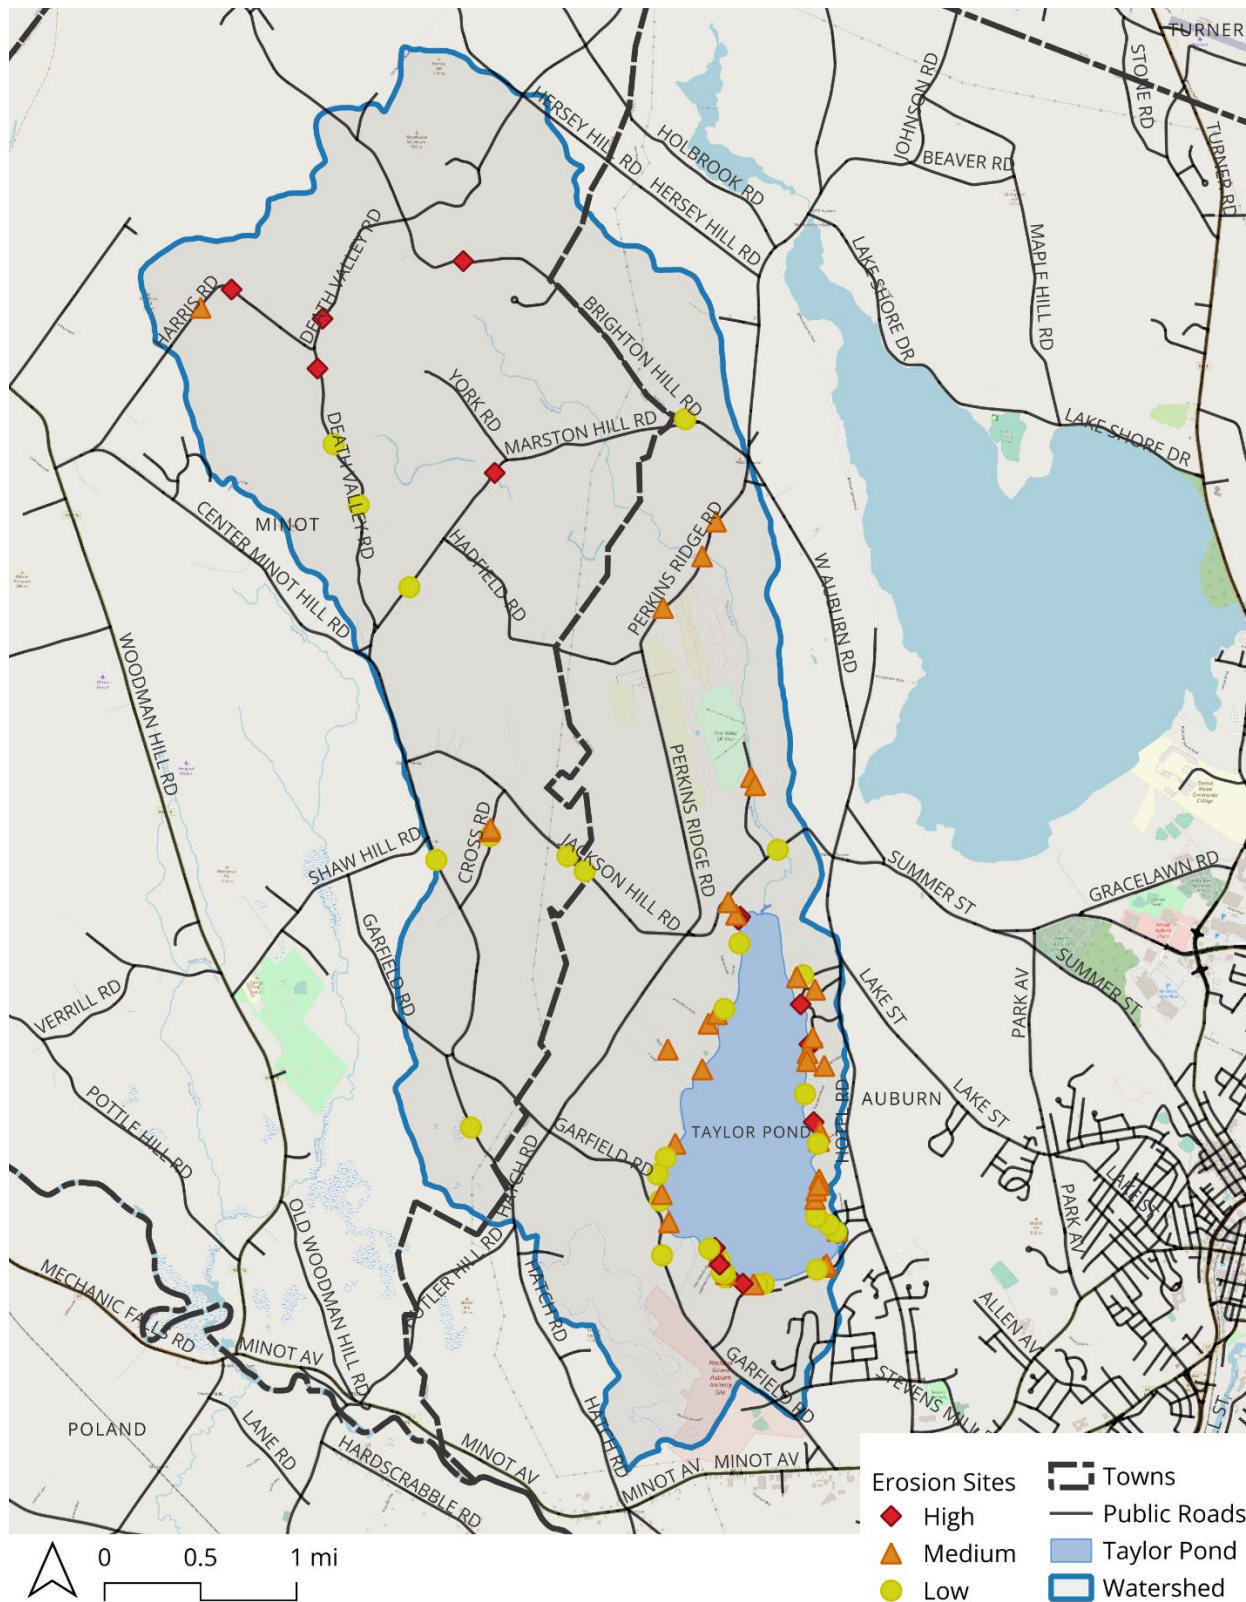
Figure 5: Watershed Map with 83 Identified Erosion Sites

During the 2023 Taylor Pond Watershed Survey **83 sites** were identified as current or potential sources of pollution to the ponds water quality (Figure 5). This is significantly less than the number of sites identified during the last survey in 2005.

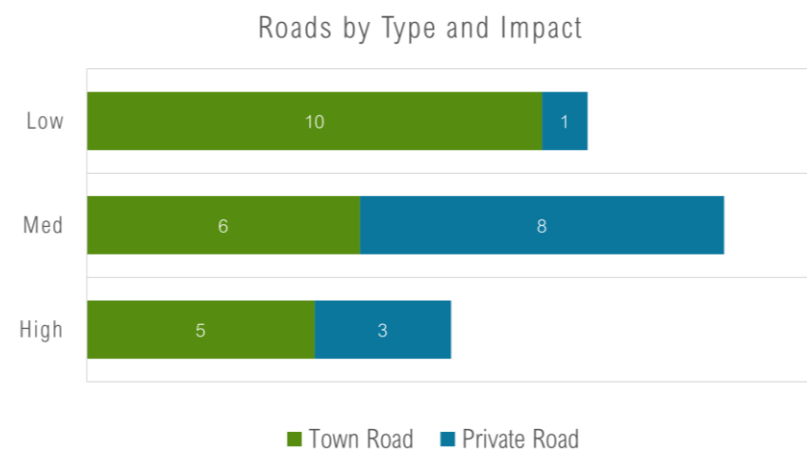
Figure 10: Roads by type and Impact

Town roads made up the second largest category by site type (25%) with private roads third (14%). This totals 33 erosion sites identified on roads (both town and private). 8 roads were identified as high impact, 14 roads were identified as medium impact, and 11 roads were identified as low impact (Figure 10).

Common problems at road sites included road shoulder erosion, culvert needing replacing (too small, perched, misaligned, crushed, etc.), and inadequate ditching or ditch erosion. Road erosion tends to be a larger problem with a greater impact to the pond. Focusing efforts on fixing these problems will dramatically reduce erosion and sedimentation leading to the pond, in turn, improving overall water quality. This will require reaching out to towns and road associations to accomplish the work.
